Introduction

The development of this Management Plan has come about through a sub-regional project developed by Coorong Tatiara Local Action Plan staff and South East NRM staff to identify areas of the Tatiara Creek where management actions such as fencing to manage stock, weed control, erosion control and revegetation to improve the condition of the Creek.

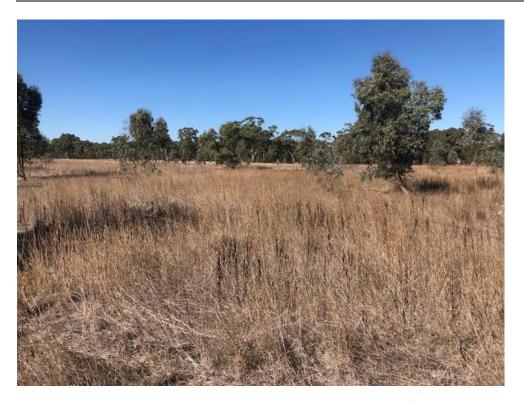
Left un-grazed and unmanaged, perennial pasture grasses can overtake a watercourse.

Perennial grassy weeds can be controlled using a non-selective herbicide approved for use near a watercourse. The herbicide should be applied according to the label instructions. It is important to apply it when the plants are actively growing, such as in late Autumn or Spring to early Summer. If the grasses have a lot of dead matter, control will be more effective if the grass is slashed or grazed first and the regrowth sprayed.

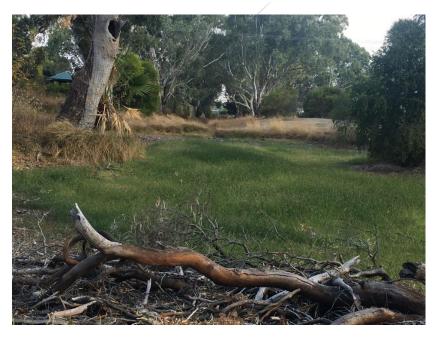
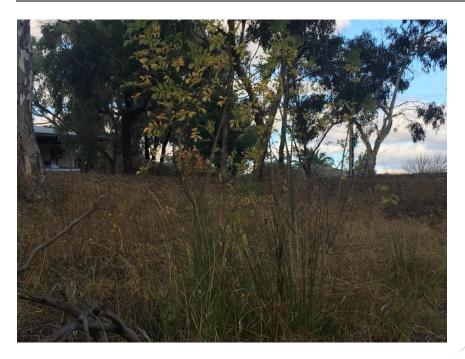
Very few woody weeds occur along the Tatiara Creek. Woody weeds such as Wild Ash (*Fraxinus sp.*) and Cotton Palm (*Washingtonia robusta*) were detected within the Bordertown township notably at Rouse waterhole and along sections of the Creek within the township.

Rouse waterhole, escaped garden plants including wild ash trees and cotton palms.

This area would benefit from removal of woody and escaped garden plant weeds, maintenance of regrowth and maintenance to remove build-up of organic matter, tree branches/debris and litter.

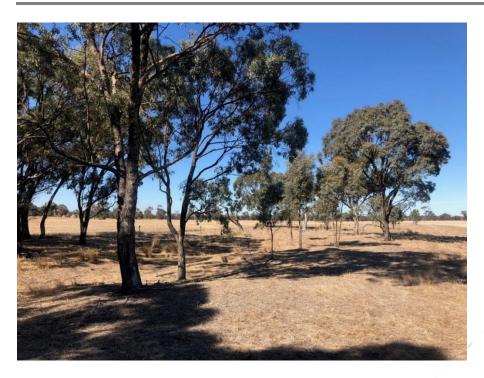
Example of single fenced Tatiara Creek line along Edwards/Ridegeway (north) boundary.

The Creek is fenced on one side along Edwards/Ridgeway (north) boundary and it is recommended double fencing if funding becomes available (approx.2kms.). Both landholders are willing to complete fencing and are flexible as to utilising different weed control methods i.e. controlled crash grazing, chemical control, mechanical slashing etc.

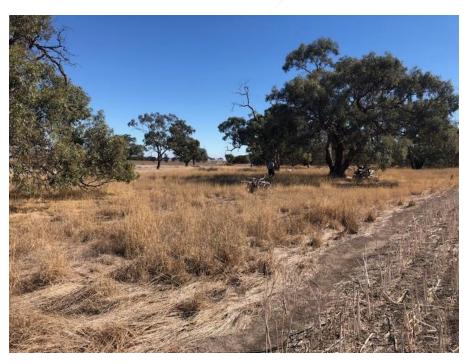
An unfenced reserve of approximately 40 hectares located on the Creek line east of Pine Hill Rd on the property boundary of Ridgeway & Langley contains mature stands of River Box (*E. largiflorens*) & Redgums (*E. camaldulensis*) and is surrounded by cropping paddocks.

Unfenced reserve containing mature Redgums, Riverbox and Broad leaved box.

- Double fencing Creek line with a minimum buffer of ten meters;
- Fence off reserve located on Creek line east of Pine Hill Rd on the property boundary of Ridgeway & Langley;

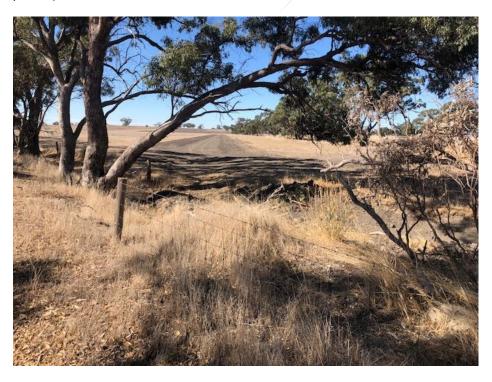
The Creek continues in a north easterly direction through Eats & Langley properties and comprises a mixture of scattered River Box (*E. largiflorens*) and Bluegums (*E. leucoxlyn*) together with cleared and widened spoon drain type culverts to accommodate cropping in surrounding paddocks (see below picture).

An example of how the Creek has been transformed into more of a drain than a creek.

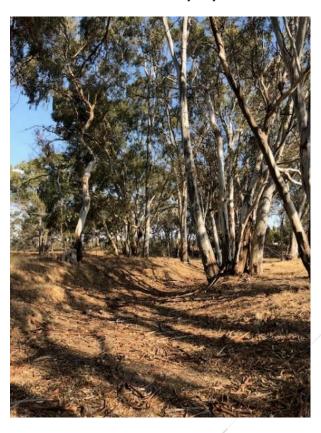
The trees show scars of harvesting and have regenerated back to healthy mature trees today (refer below pic).

Evidence of trees being harvested for their timber along the Creek line approximately 2kms north of Bordertown.

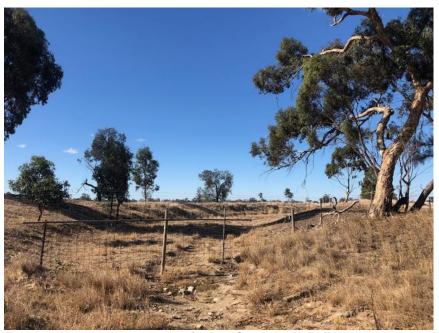
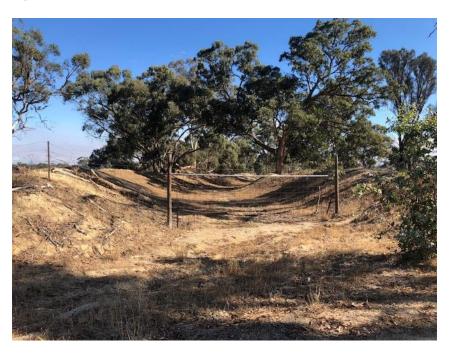
Finlayson Road to Senior Road. Within this zone much of the natural Creek has been deepened with large banks so that normal flooding across the flats is restricted to the Creek line.

Top and Bottom: An example of steep Creek banks within zone 2 at road/creek crossing on Finlayson Rd.

It is recommended that scheduled maintenance of fence lines at the end of autumn/winter be undertaken at Creek crossings to ensure integrity is maintained so stock are safely contained.

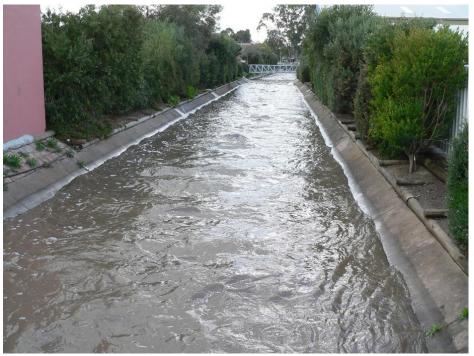
Within Bordertown precinct between North Terrace and South Terrace the Creek line has been transformed into concrete culverts thereby minimising the effects of stream bank erosion at that location. This also removes any possibility of revegetation/restoration efforts in this area.

Tatiara Creek within township September 2010.

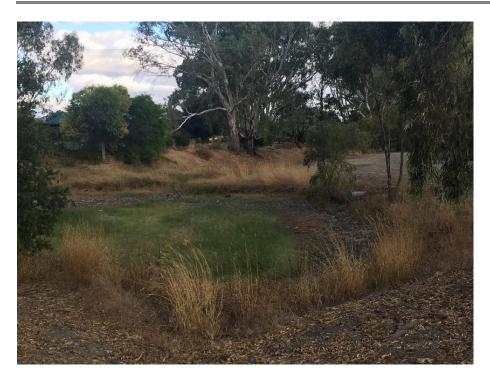
Rouse waterhole.

Rouse waterhole as its name suggests is a deeper section of the Creek which tends to remain wet/damp for most of the year. It is however at threat of being over-run by escaped garden plants and other weeds which will restrict any native plant recruitment.

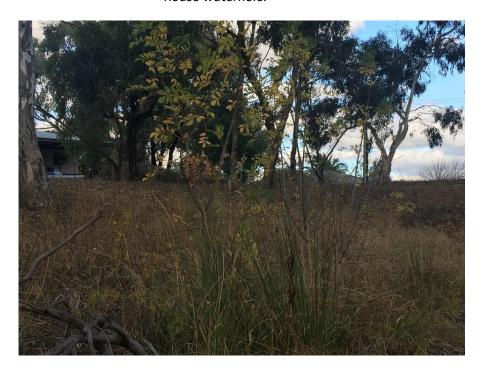
Rouse waterhole; example of exotic Wild Ash tree.

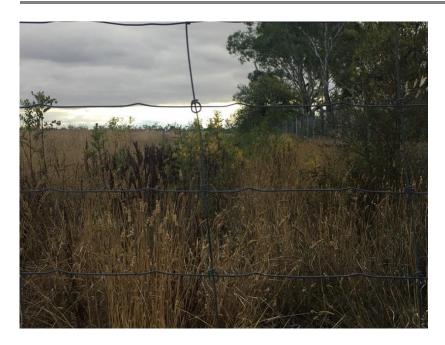
Weeds along Creek at road crossing on Clayton Farm Rd.

Routine maintenance is required to keep fencelines at road crossings clear of debris and ensure effectiveness for stock control. Control of perennial grasses such as *Phalaris* which can form dense tussocks restrict the natural flow of water causing unnecessary diversions potentially leading to erosion of areas not usually subject to flowing water.

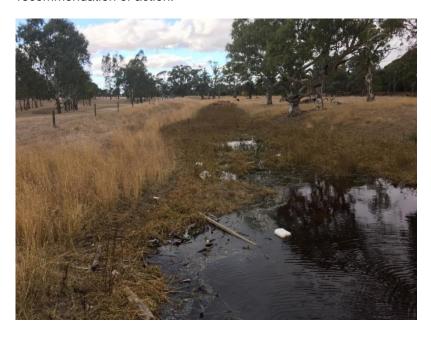
Litter appears to be a problem at the intersection of Meatworks Rd with the Creek (see image below). A further investigation is needed to determine the source of the litter to enable an appropriate recommendation of action.

General litter polluting the Creek at Meatworks Road.

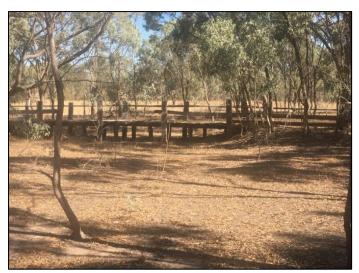
Mature fringing Bluegum (*Eucalyptus leucoxlyn*) and Redgum (*E. camaldulensis*) occur along the Creek line in this area. Soils are black/grey cracking clays with evidence of runaway holes appearing.

Zone 5 example focusing on eastern section of Jamie Edwards property close to SA/Vic border.

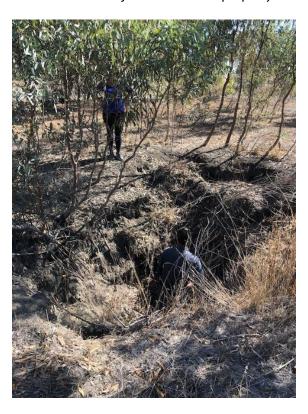
Runaway hole appearing at eastern end of Jamie Edwards property.

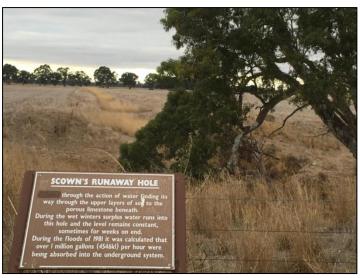
Scown's Runaway Hole

Poocher Swamp contains a series of large runaway holes which diverts high volumes of surface water flows underground, but once the Swamp reaches capacity the water overflows to the west to the most western known runaway hole called Scown's Runaway Hole.
