# Tatiara Creek Report

## Introduction

The development of this Management Plan has come about through a sub-regional project developed by Coorong Tatiara Local Action Plan staff and South East NRM staff to identify areas of the Tatiara Creek where management actions such as fencing to manage stock, weed control, erosion control and revegetation to improve the condition of the Creek.

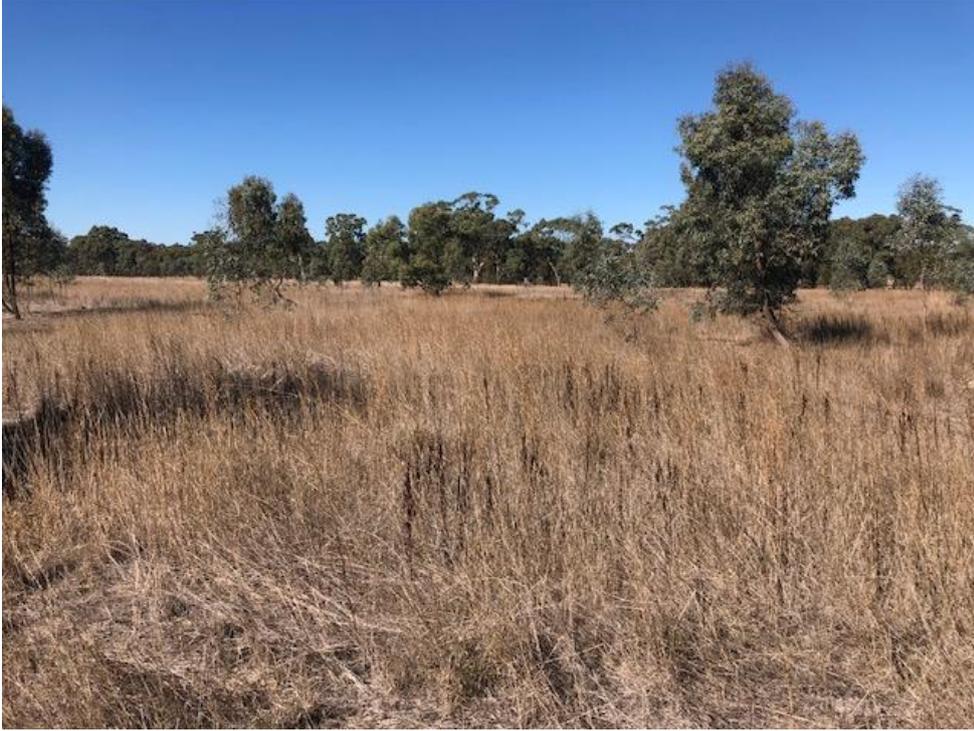
*Left un-grazed and unmanaged, perennial pasture grasses can overtake a watercourse.*

Perennial grassy weeds can be controlled using a non-selective herbicide approved for use near a watercourse. The herbicide should be applied according to the label instructions. It is important to apply it when the plants are actively growing, such as in late Autumn or Spring to early Summer. If the grasses have a lot of dead matter, control will be more effective if the grass is slashed or grazed first and the re-growth sprayed.

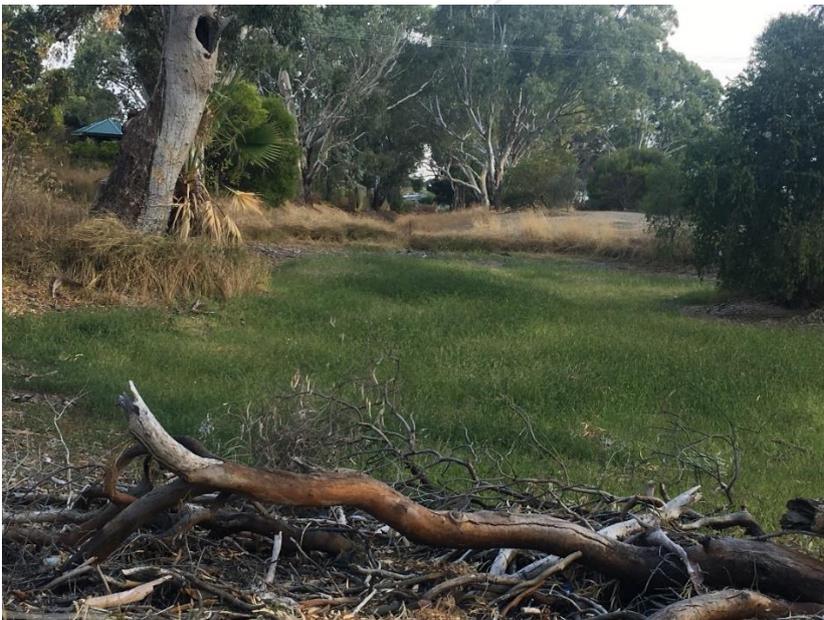
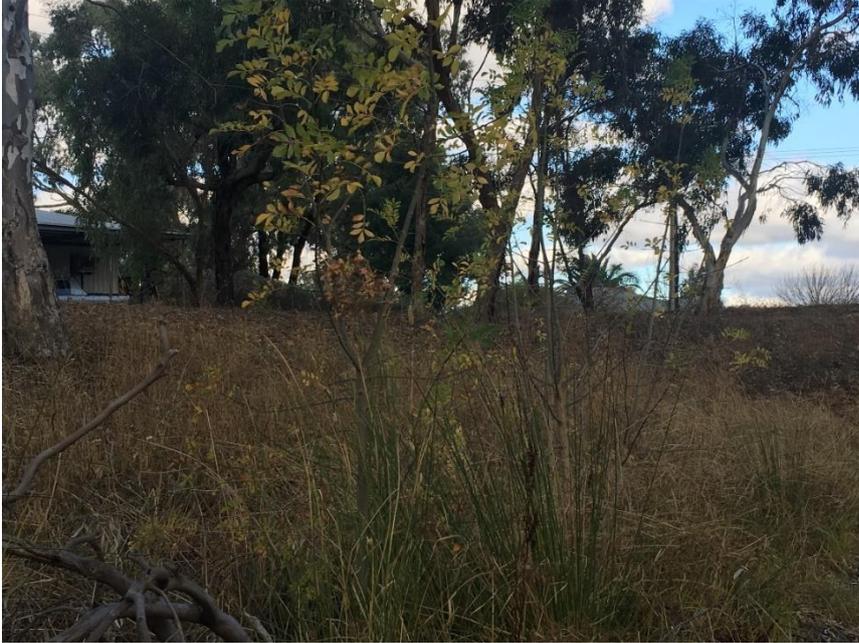
Very few woody weeds occur along the Tatiara Creek. Woody weeds such as Wild Ash (*Fraxinus sp.*) and Cotton Palm (*Washingtonia robusta*) were detected within the Bordertown township notably at Rouse waterhole and along sections of the Creek within the township.

*Rouse waterhole, escaped garden plants including wild ash trees and cotton palms.*

This area would benefit from removal of woody and escaped garden plant weeds, maintenance of re-growth and maintenance to remove build-up of organic matter, tree branches/debris and litter.

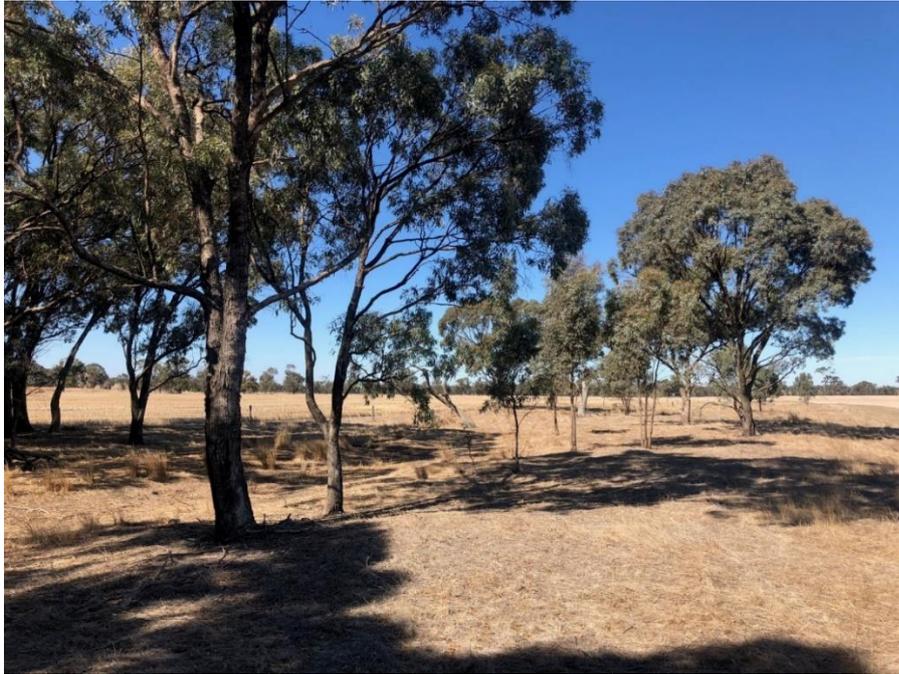
*Example of single fenced Tatiara Creek line along Edwards/Ridegeway (north) boundary.*

The Creek is fenced on one side along Edwards/Ridgeway (north) boundary and it is recommended double fencing if funding becomes available (approx.2kms.). Both landholders are willing to complete fencing and are flexible as to utilising different weed control methods i.e. controlled crash grazing, chemical control, mechanical slashing etc.

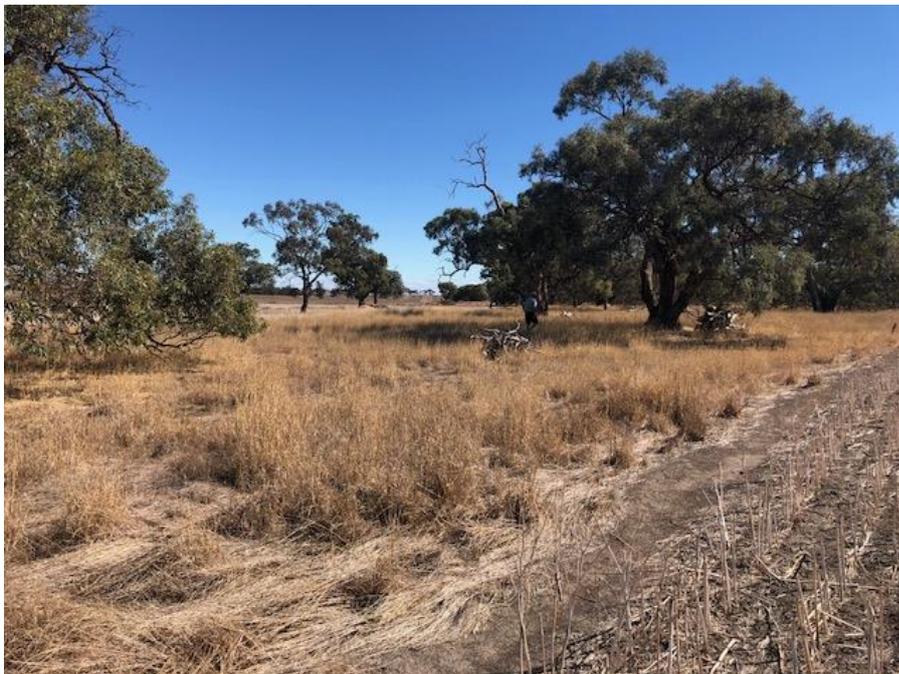
An unfenced reserve of approximately 40 hectares located on the Creek line east of Pine Hill Rd on the property boundary of Ridgeway & Langley contains mature stands of River Box (*E. largiflorens*) & Redgums (*E. camaldulensis*) and is surrounded by cropping paddocks.

*Unfenced reserve containing mature Redgums, Riverbox and Broad leaved box.*

- Double fencing Creek line with a minimum buffer of ten meters;
- Fence off reserve located on Creek line east of Pine Hill Rd on the property boundary of Ridgeway & Langley;

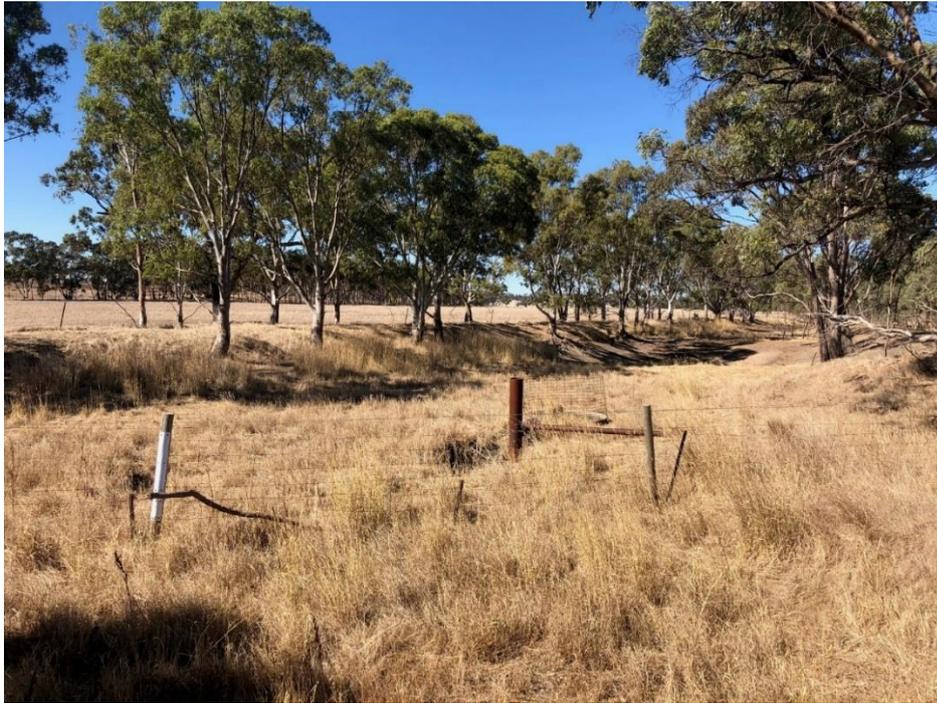
The Creek line from Pine Hill Road Bridge to Ridgeways was planted out with River Red Gums (*Eucalyptus camaldulensis*) from 1970 to 1995 by Ian Ridgeway. Redgums are reluctant to grow in this location as the soil types are more suited to River Box (*E. largiflorens*).

*Tatiara Creek line planted out with River Redgums (*Eucalyptus camaldulensis*) by Ian Ridgeway.*

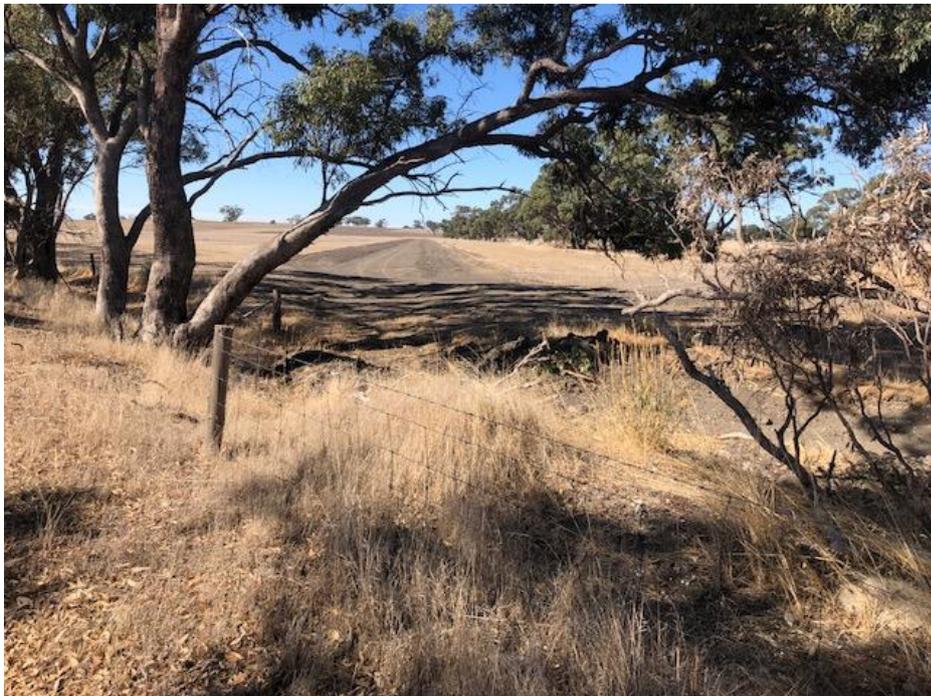
The Creek continues in a north easterly direction through Eats & Langley properties and comprises a mixture of scattered River Box (*E. largiflorens*) and Bluegums (*E. leucoxlyn*) together with cleared and widened spoon drain type culverts to accommodate cropping in surrounding paddocks (see below picture).

*An example of how the Creek has been transformed into more of a drain than a creek.*

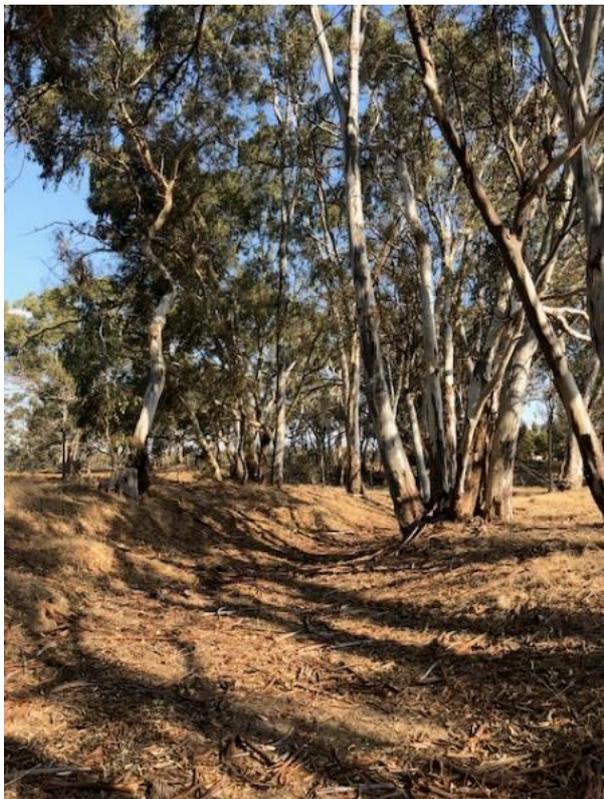
The trees show scars of harvesting and have regenerated back to healthy mature trees today (refer below pic).

*Evidence of trees being harvested for their timber along the Creek line approximately 2kms north of Bordertown.*

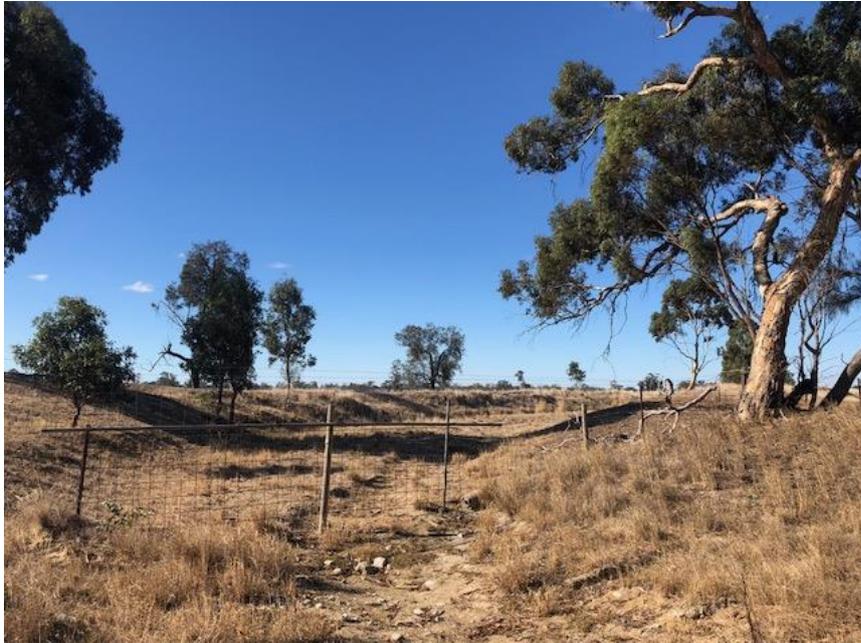
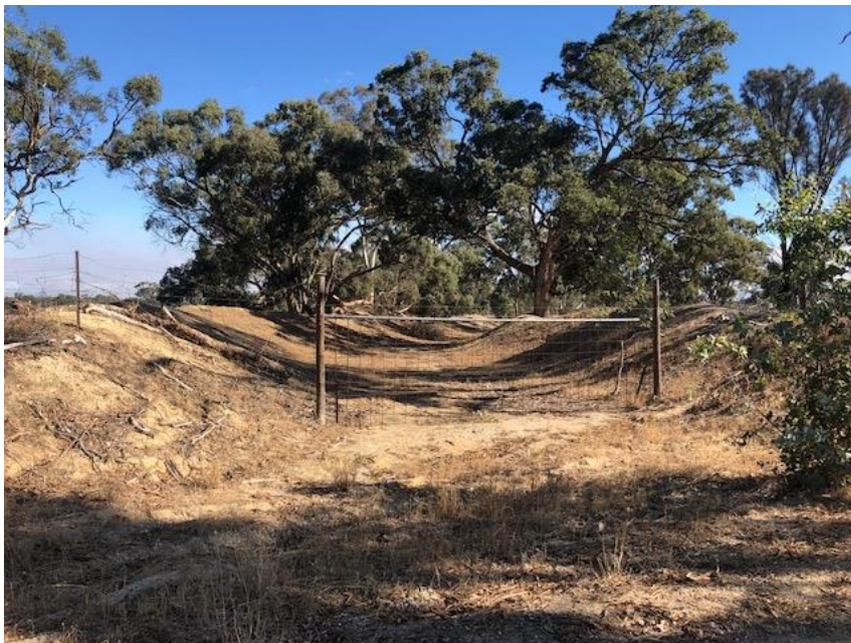
Finlayson Road to Senior Road. Within this zone much of the natural Creek has been deepened with large banks so that normal flooding across the flats is restricted to the Creek line.

*Top and Bottom: An example of steep Creek banks within zone 2 at road/creek crossing on Finlayson Rd.*

It is recommended that scheduled maintenance of fence lines at the end of autumn/winter be undertaken at Creek crossings to ensure integrity is maintained so stock are safely contained.

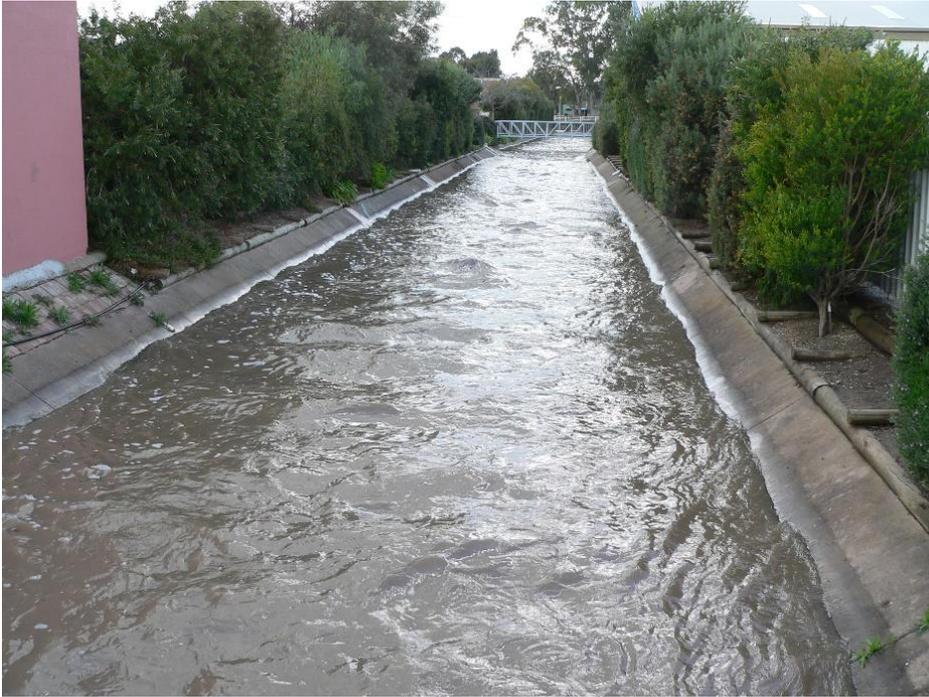
Within Bordertown precinct between North Terrace and South Terrace the Creek line has been transformed into concrete culverts thereby minimising the effects of stream bank erosion at that location. This also removes any possibility of revegetation/restoration efforts in this area.

*Tatiara Creek within township September 2010.*

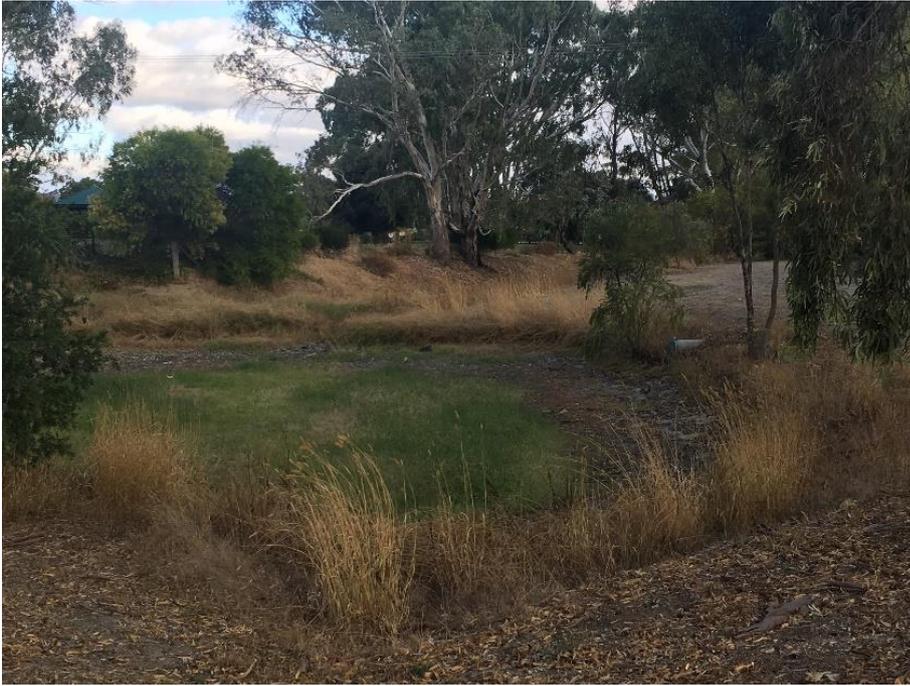
Rouse waterhole as its name suggests is a deeper section of the Creek which tends to remain wet/damp for most of the year. It is however at threat of being over-run by escaped garden plants and other weeds which will restrict any native plant recruitment.

*Rouse waterhole.*

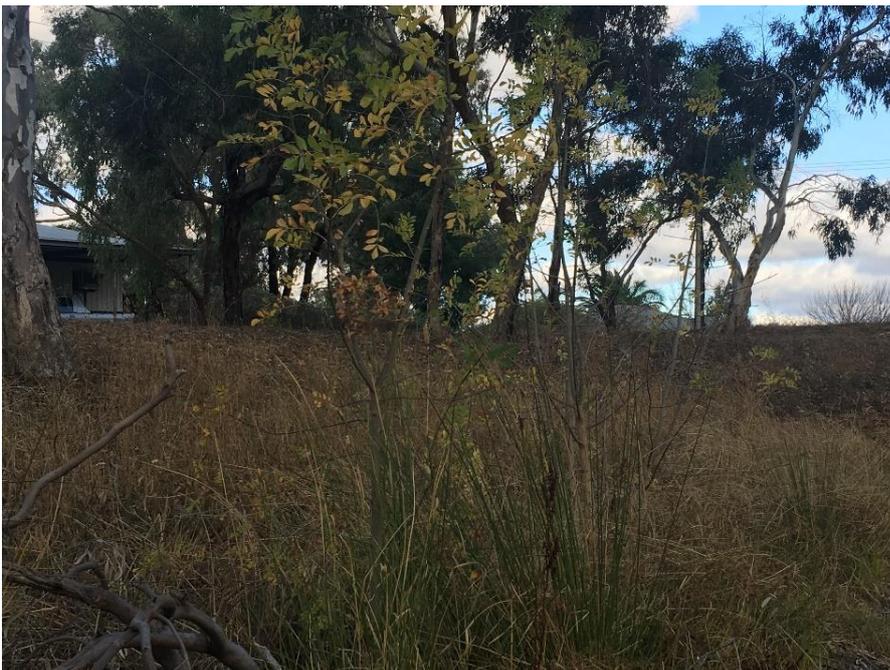
*Rouse waterhole; example of exotic Wild Ash tree.*

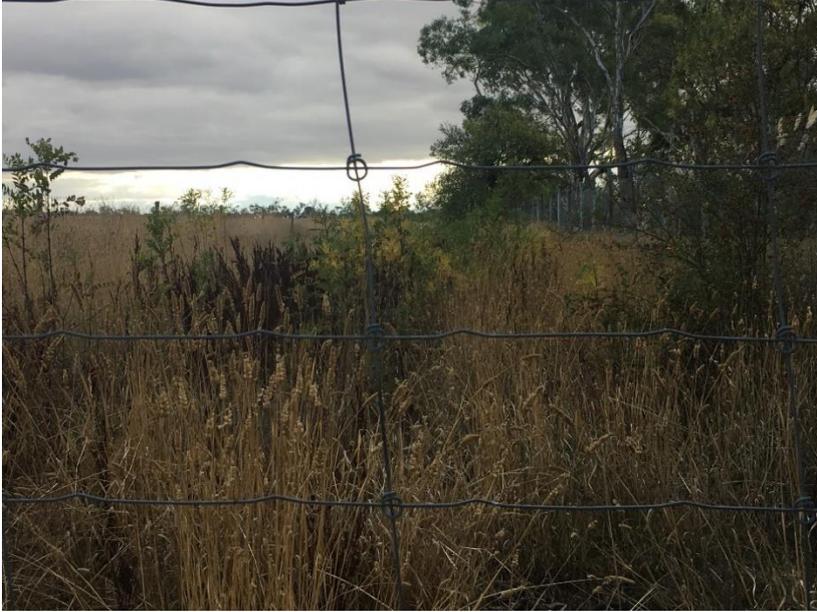
*Weeds along Creek at road crossing on Clayton Farm Rd.*

Routine maintenance is required to keep fencelines at road crossings clear of debris and ensure effectiveness for stock control. Control of perennial grasses such as *Phalaris* which can form dense tussocks restrict the natural flow of water causing unnecessary diversions potentially leading to erosion of areas not usually subject to flowing water.

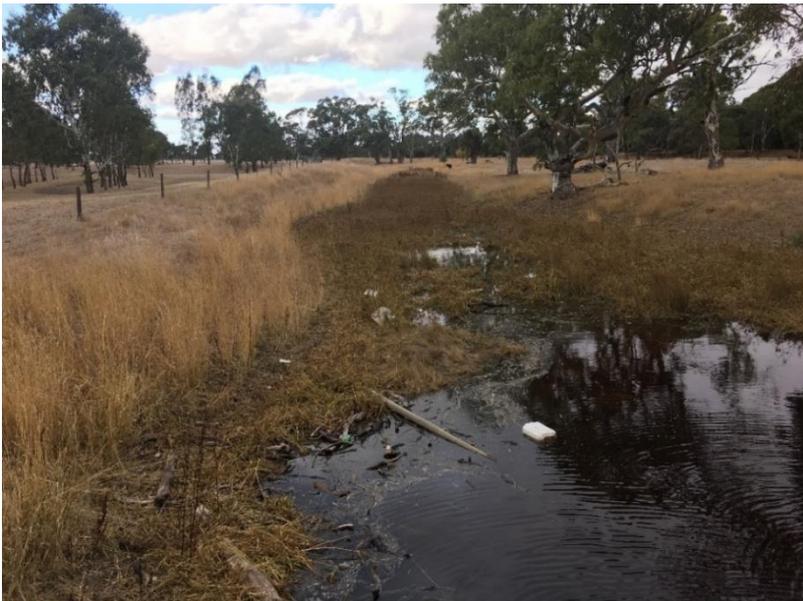
Litter appears to be a problem at the intersection of Meatworks Rd with the Creek (see image below). A further investigation is needed to determine the source of the litter to enable an appropriate recommendation of action.

*General litter polluting the Creek at Meatworks Road.*

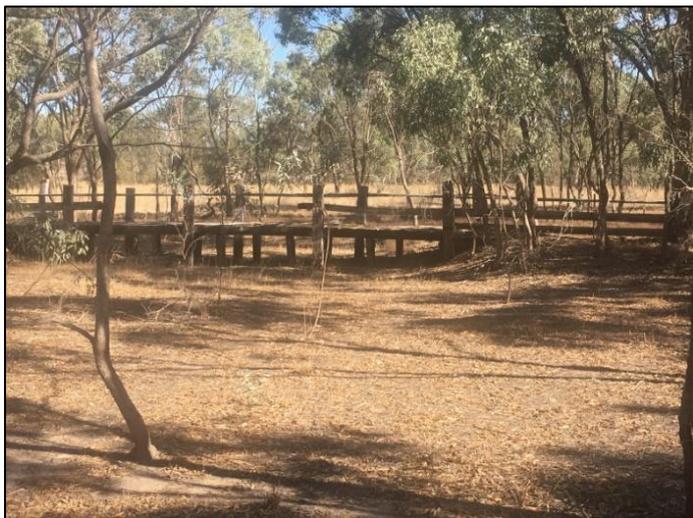
Approximately forty years ago an area of approximately three hectares on Jamie Edwards property was fenced off at the eastern end of Tatiara Creek nearest the border. Natural regeneration of Riverbox (*Eucalyptus largiflorens*), small pockets of Bull mallee (*E. behriana*), and Buloke (*Allocasuarina leuhmannii*) trees have naturally regenerated over various flood events during this time.

Mature fringing Bluegum (*Eucalyptus leucoxlyn*) and Redgum (*E. camaldulensis*) occur along the Creek line in this area. Soils are black/grey cracking clays with evidence of runaway holes appearing.

Zone 5 example focusing on eastern section of Jamie Edwards property close to SA/Vic border.

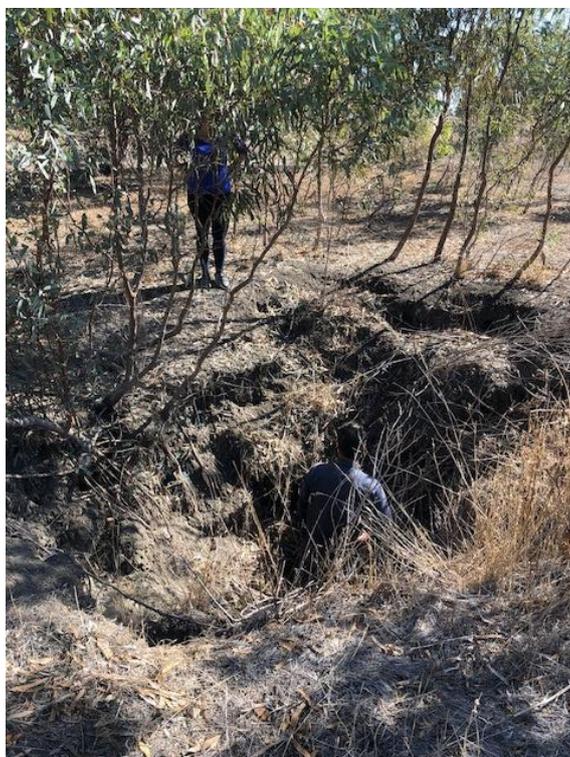
Runaway hole appearing at eastern end of Jamie Edwards property.

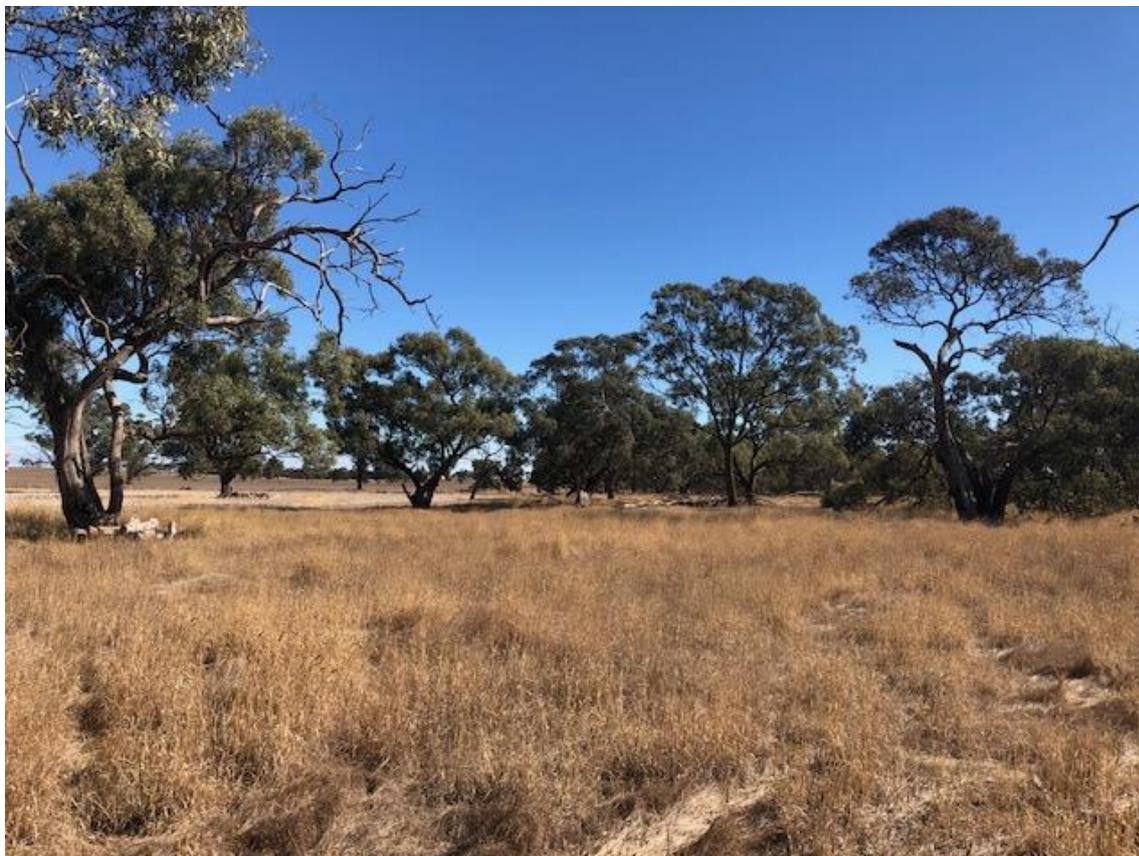
*Fenced off reserve (approximately 5 hectares) located at Langley/Milne crossroads supports a good healthy community of Black Box (Eucalyptus largiflorens).*

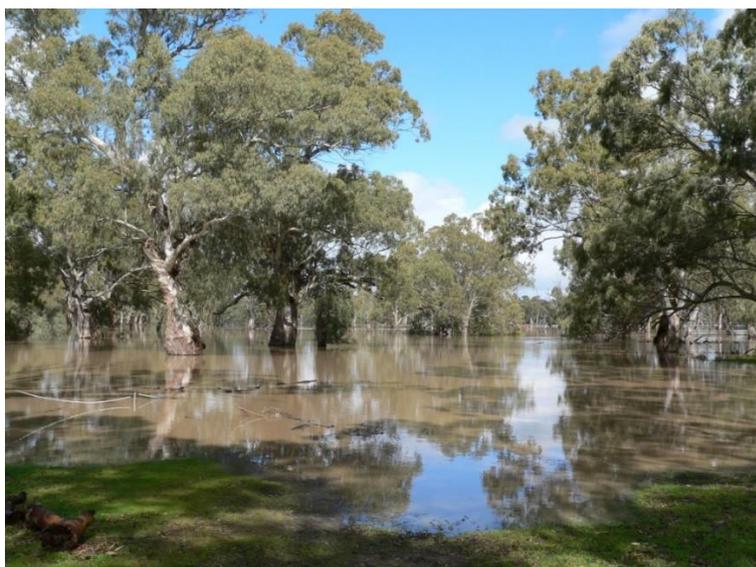
The Poocher Swamp Reserve covers a total area of 77 hectares. In the late 1950s, a number of levee banks were constructed in the swamp to impound water and attract bird life. The swamp fills from Tatiara Creek. The impoundment of water over many years has caused the inundation of the river red gums (*Eucalyptus camaldulensis*), and consequently many have died but extensive regrowth is occurring at the upper limits of the flood waters and at the entrance of Tatiara Creek in to the swamp.

Understorey vegetation is mostly weed species. These are numerous, particularly in the muddy sections of the reserve. Aquatic species occur in the shallower sections of the reserve and are dominated by Ribbon Weed (*Triglochin procerum*), Red Water-milfoil (*Myriophyllum verrucosum*), Stonewart (*Nitella* sp), Swamp lily (*Ottelia ovalifolia*), Azalia (*Azalia filiculoides*), and several rush species.

*Poocher Swamp, September 2010.*

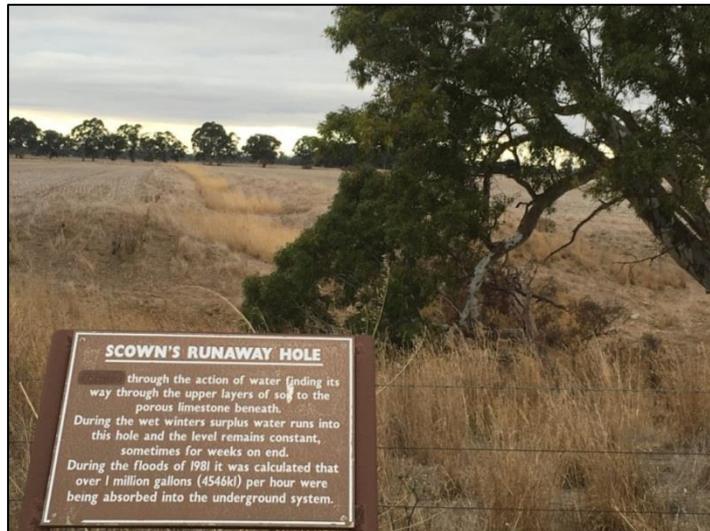
Scown's Runaway Hole

Poocher Swamp contains a series of large runaway holes which diverts high volumes of surface water flows underground, but once the Swamp reaches capacity the water overflows to the west to the most western known runaway hole called Scown's Runaway Hole.
